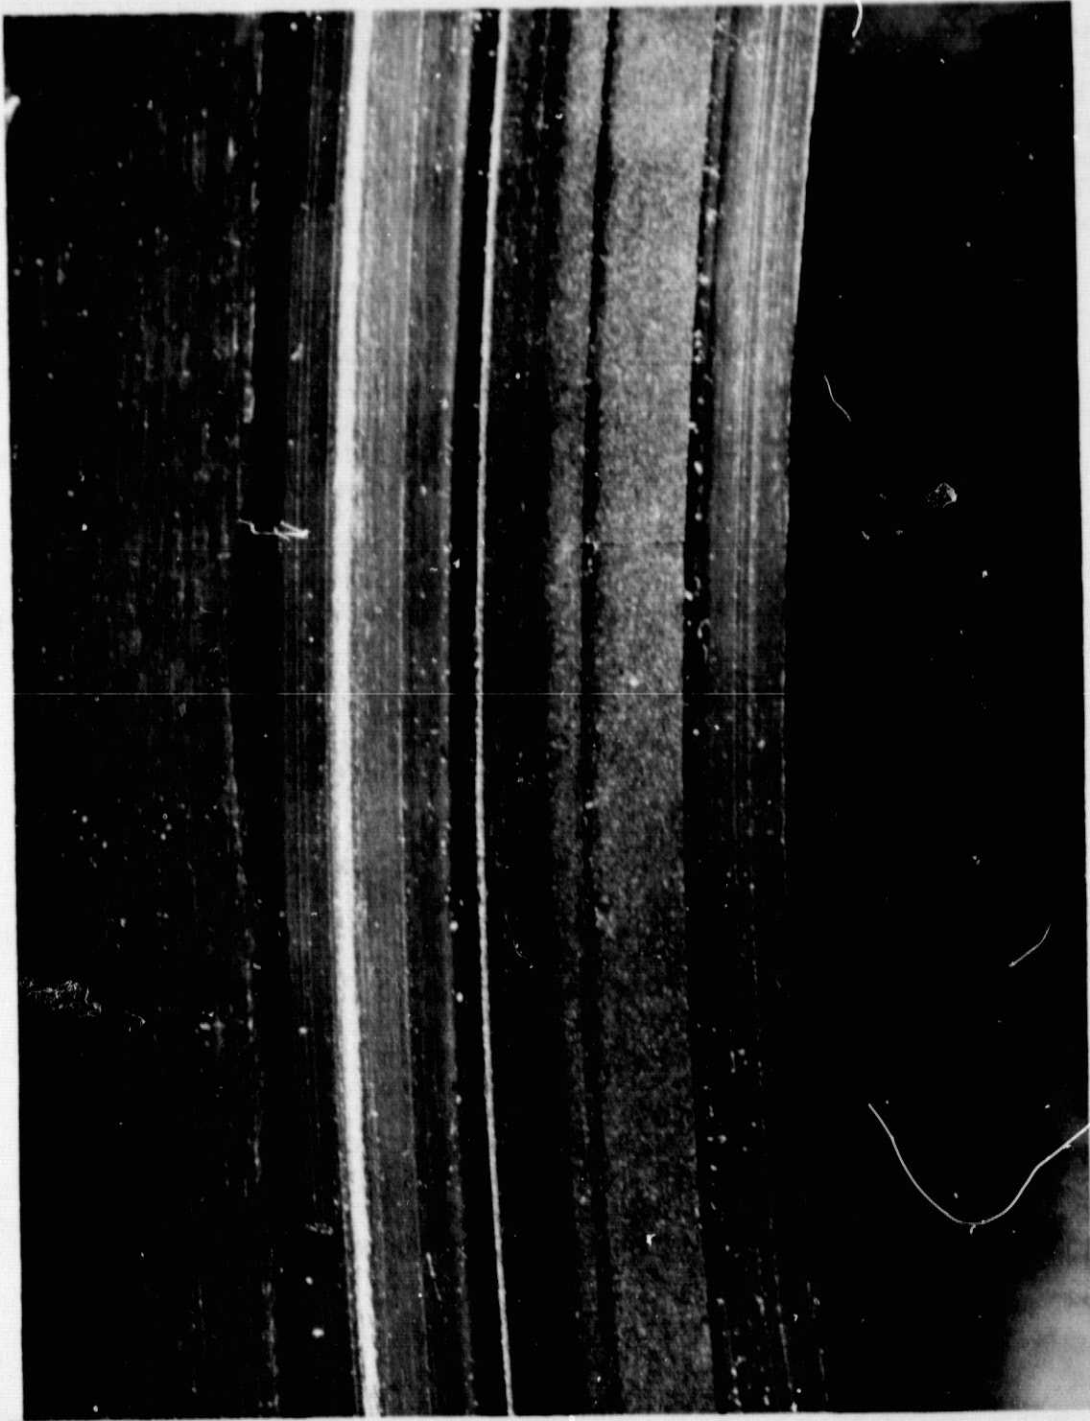
Figure 20. Seal Bore After Test.

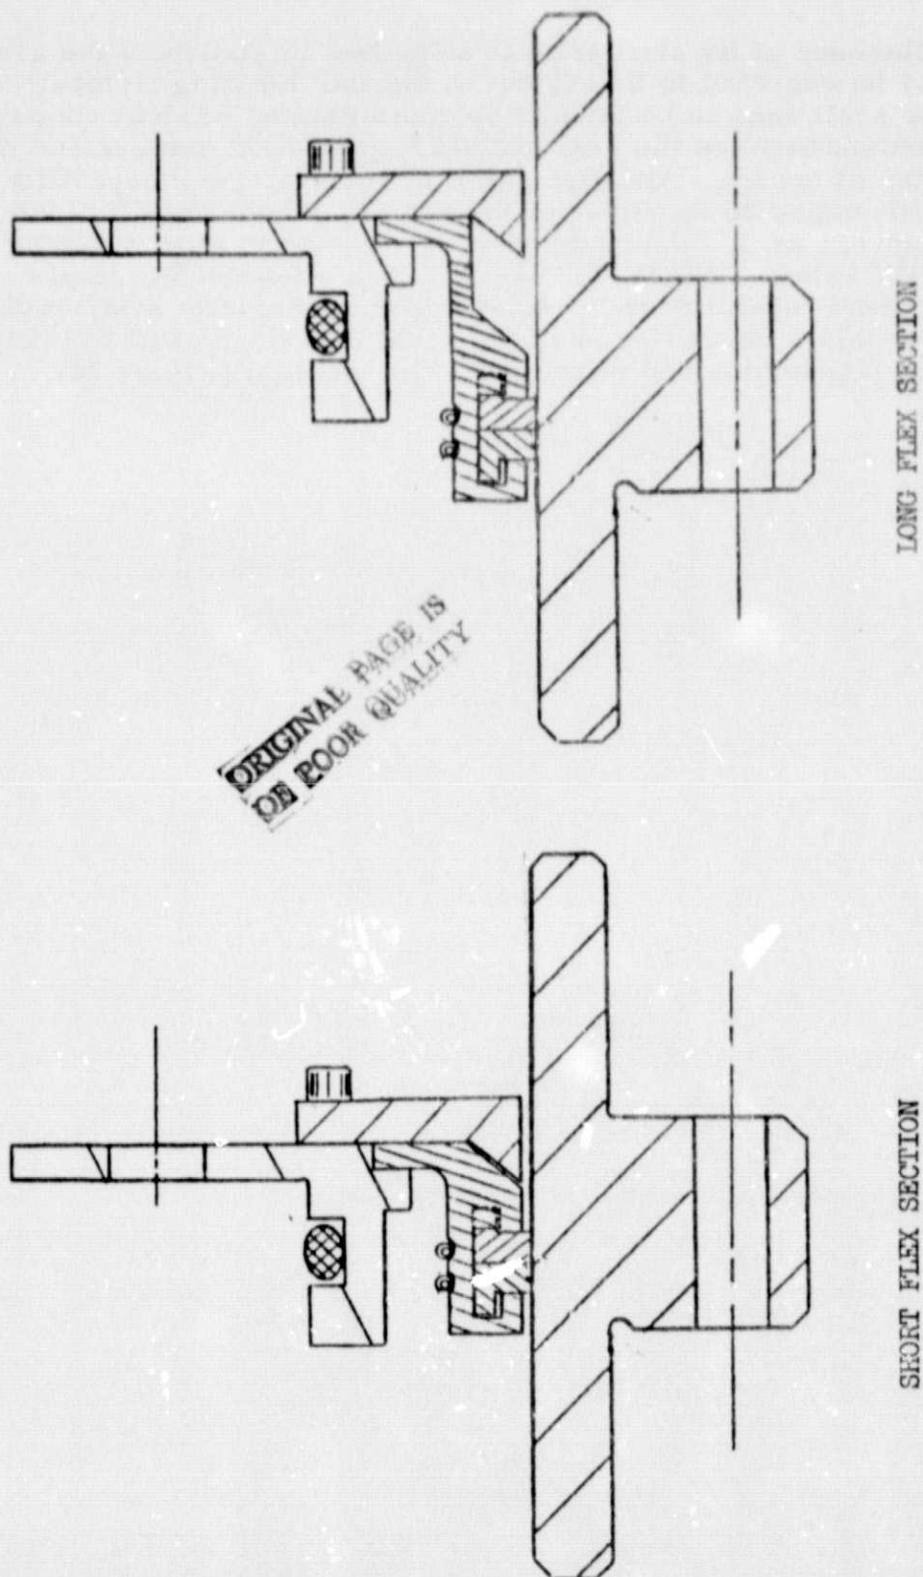
Figure 21. Short Versus Long Flex Section.

Because of its similarity to a lip seal in structure the synergistic seal may be expected to be subject to similar limiting factors. High-speed lip seals tend to be limited by combinations of shaft runout and misalignment between the seal and shaft geometric centers and heat generation at the lip. Although gains in surface speed capability can be reasonably expected by virtue of the use of carbon-graphite instead of an elastomer as a rubbing material, a dynamic shaft tracking limitations still exist. Longer flex sections are often used to improve runout and speed capability of lip seals. The synergistic seal, having a relatively thick, short flex section, could benefit in shaft following ability by lengthening and thinning out this section (Figure 21).
